July Monthly Report for the Falls Creek Hydro-electric Project
FERC # P-11659

FALLS CREEK HYDROELECTRIC-PROJECT (P-11659)
MONTHLY CONSTRUCTION REPORT TO FERC
July 2006

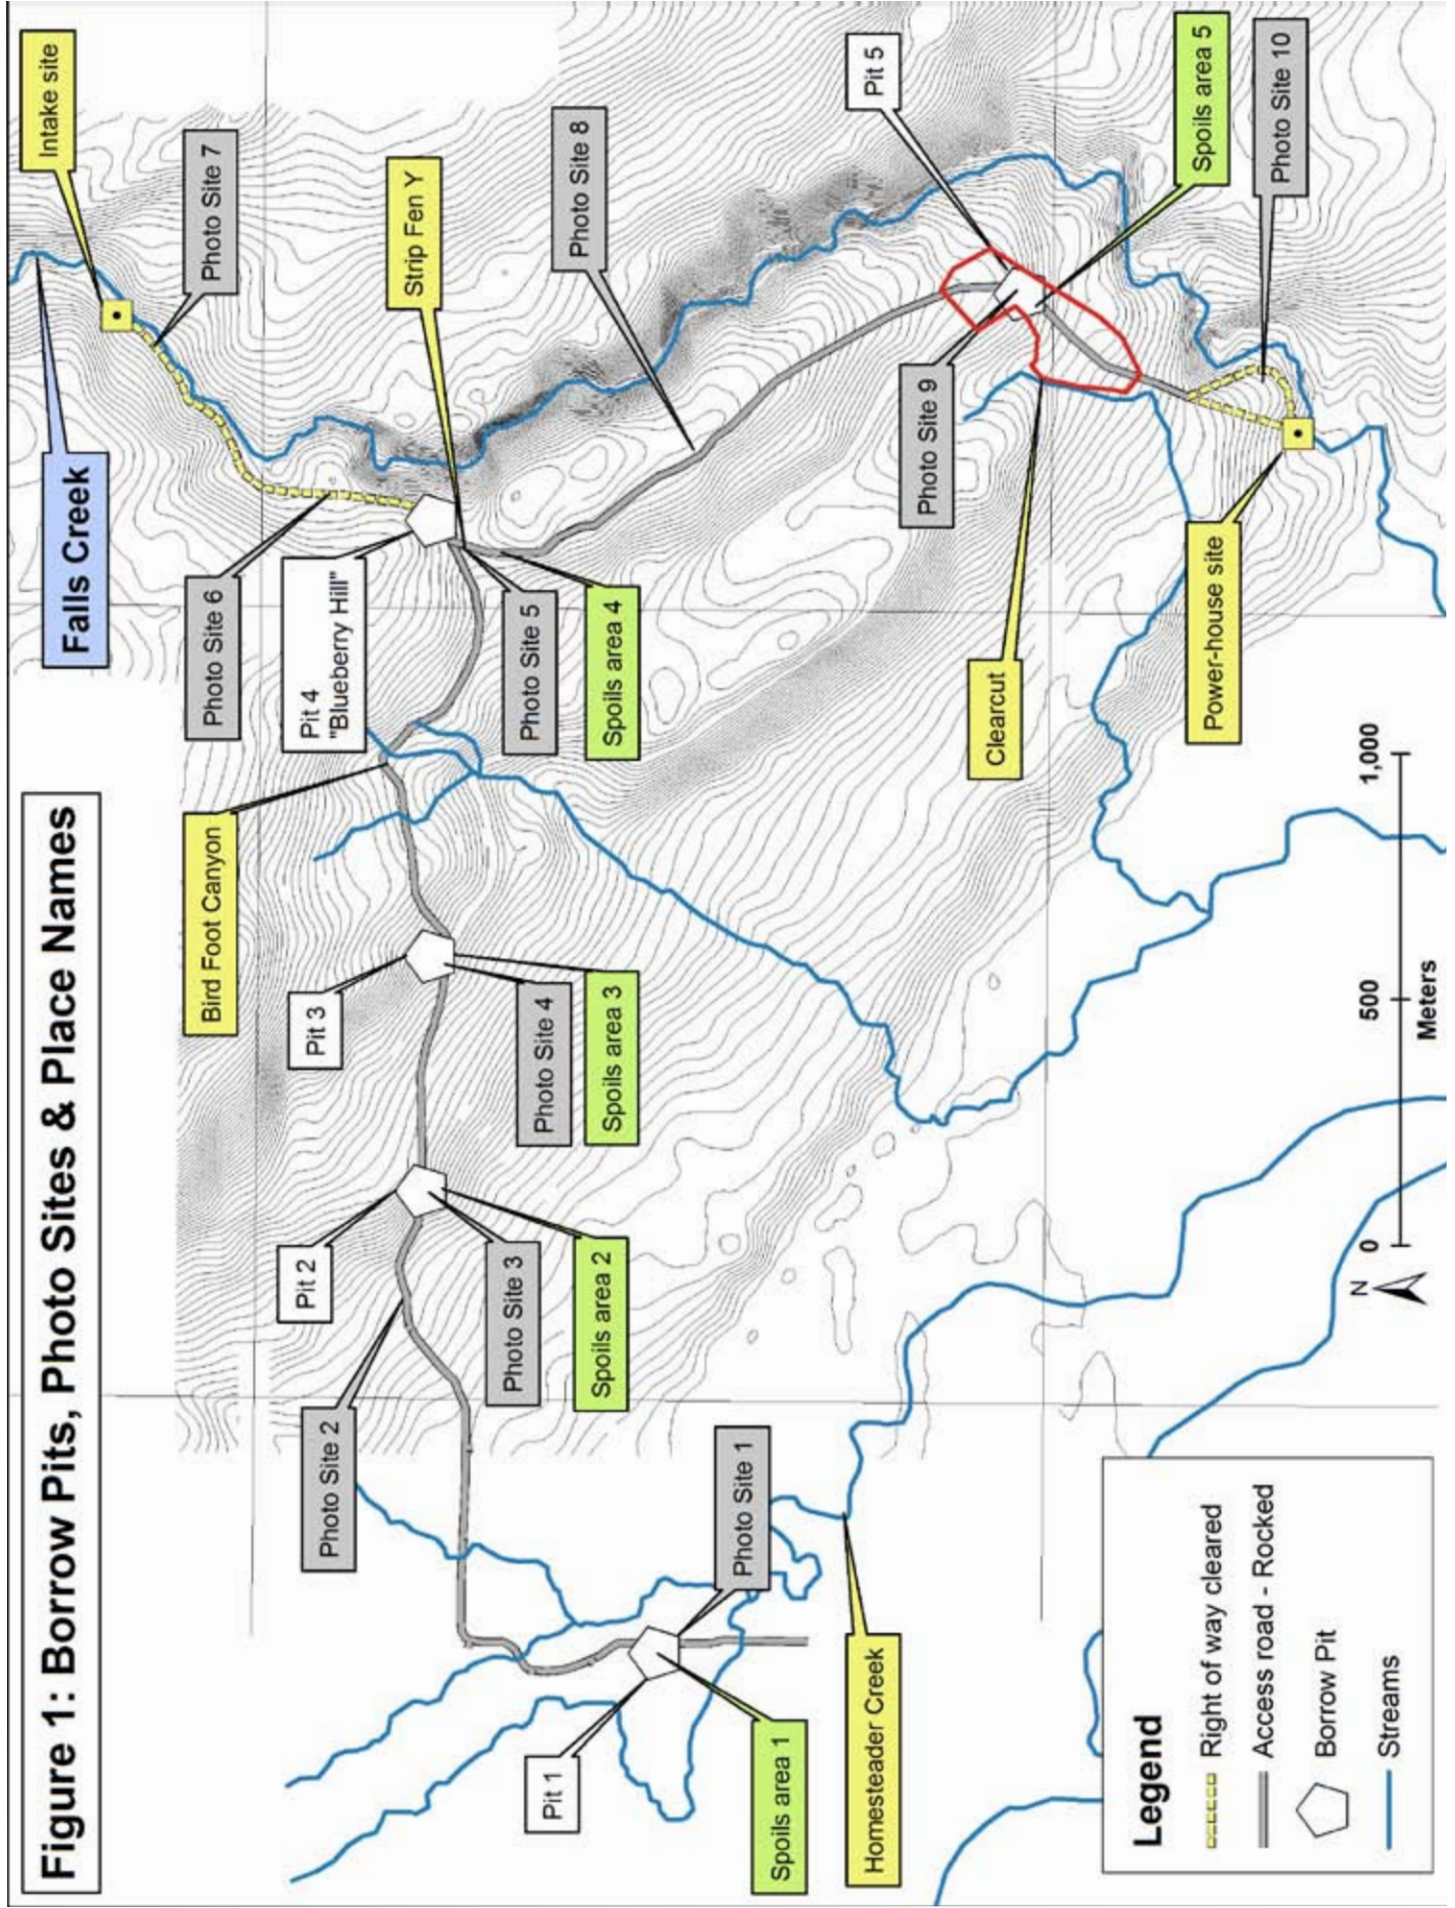
Figure 1: Borrow Pits, Photo Sites & Place Names

The month of July was devoted entirely to road construction. Additional work which supported road construction included development of pit #4, pit #5, additional blasting at pit #3, the development of spoils areas at the strip-fen Y and the clearcut, and construction of a staging area on the bluff overlooking the powerhouse (Figure 1).

approximately 250' an area that requires a 20-40' bench cut was encountered ("blueberry hill" - see Figure 1). To begin, a 100' stretch was stripped to bedrock in preparation for drilling and blasting. This area was shot on July 19th and resulted in 5,200 cu. yds. of shot rock (pit #4).

Consultation between the construction superintendent and the ECM resulted in the selection of the 4th major spoils area just south of the Strip Fen Y (see Figure 1). This area was selected in order to minimize impacts to rare wetland types, provide a slope for efficient backhauling and avoid sedimentation into the Falls Creek watershed. Deposition in this area has resulted in mass wasting as the terminal lobe lurches downhill after loading. Backhaul materials associated with construction of the intake site access road will be dumped here.

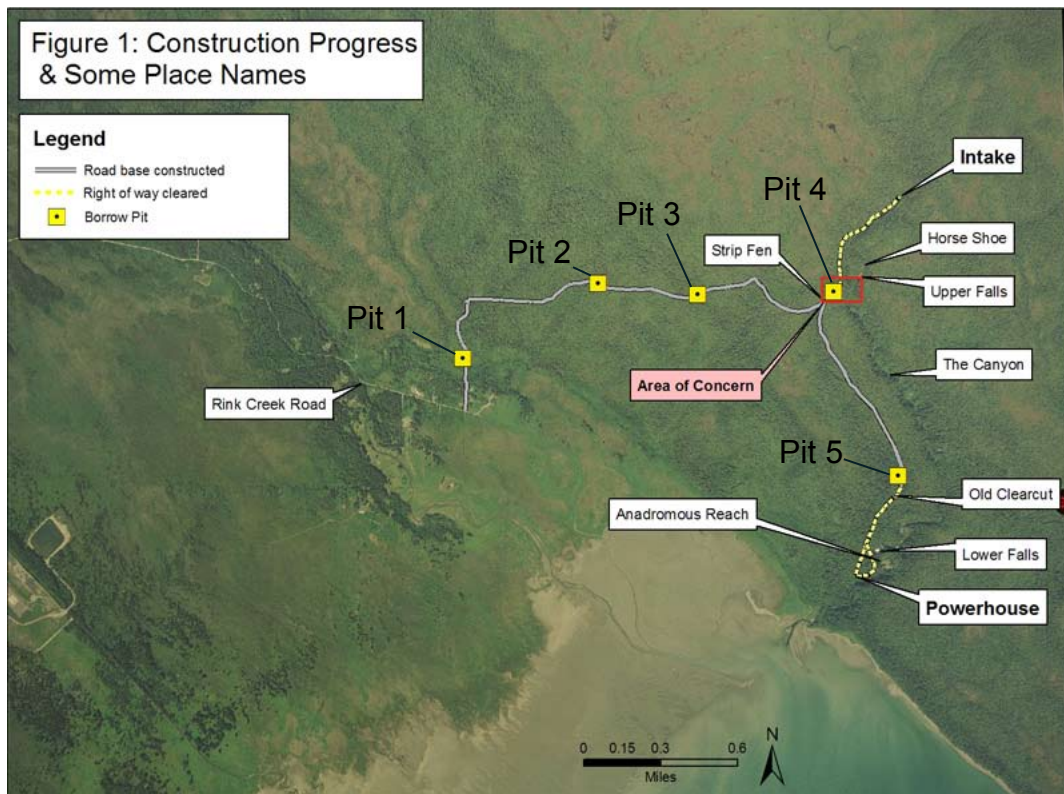
Figure 1: Construction Progress and relevant place names.

The specific concern is for the possibility of mass wasting into Falls Creek as a consequence of developing Pit #4 (figures 1,2). Pit #4, though used in the field, is misleading nomenclature - although the cut will provide a rock source for construction activities the purpose of the cut is to bring the penstock road alignment down to the necessary grade.
